## BeeLine Property Inspections

### RESIDENTIAL REPORT

1865 SW Bradford Pl  
Palm City FL 34990

Don Brooks & Amy Brooks  
JUNE 19, 2019

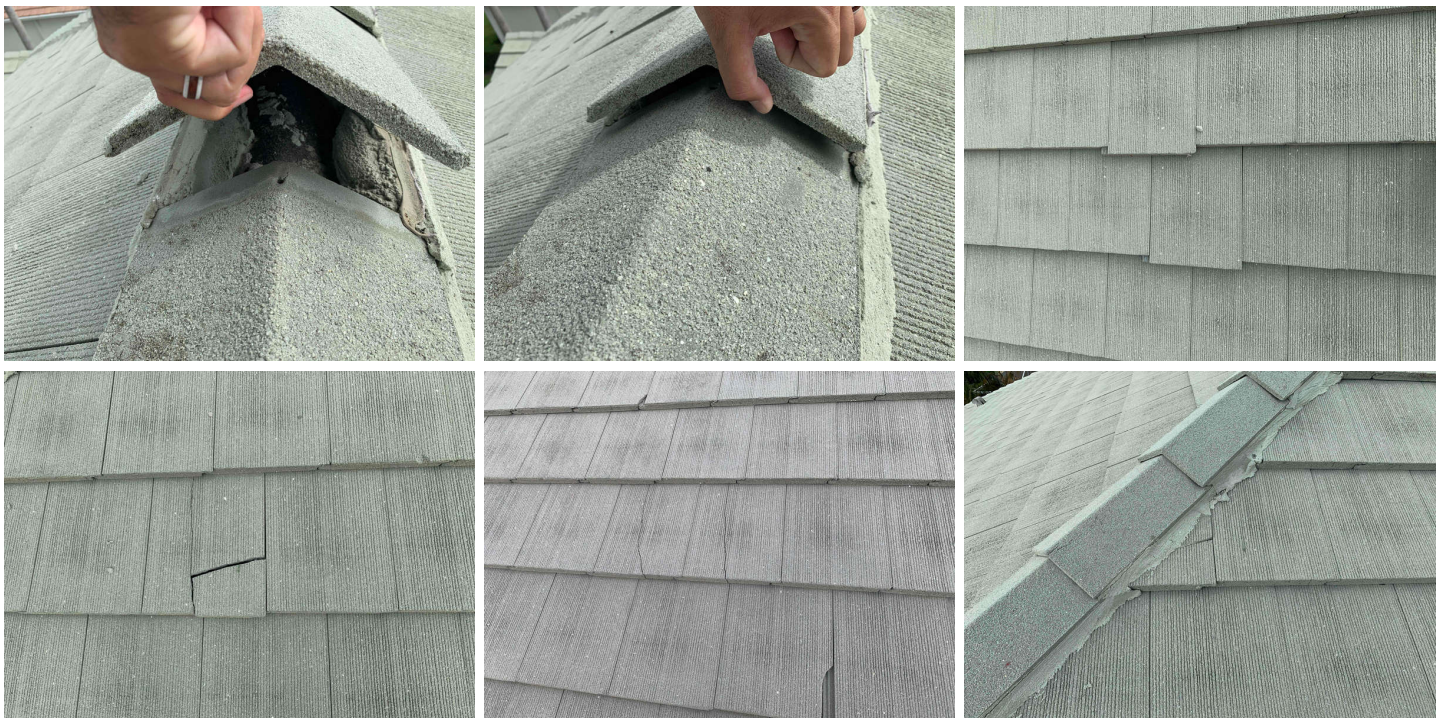
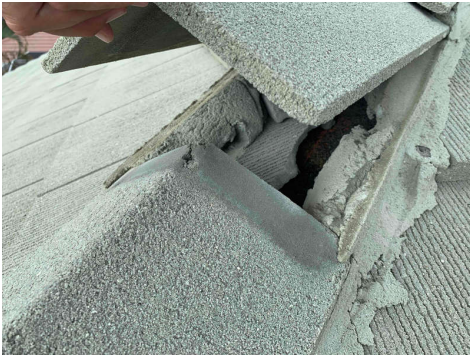
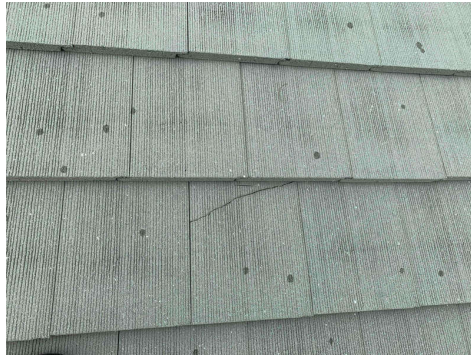
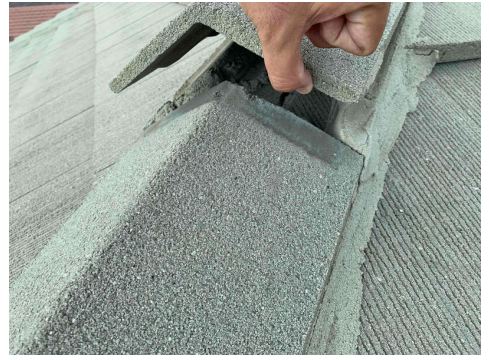
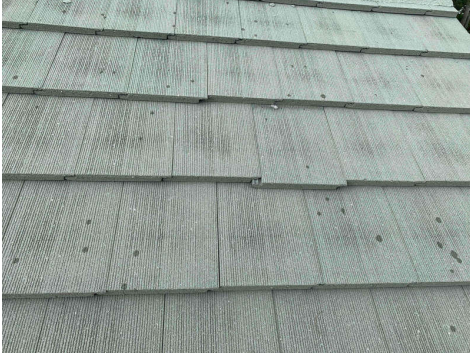
#### 2.1.1 Coverings

#### **TILES CRACKED/BROKEN AND MISSING**

Roof had Proximately 25 cracked/broken tiles. Inspector recommends a licensed roofing contractor repair or replace to prevent moisture intrusion and/or mold.

Contact a qualified roofing professional.

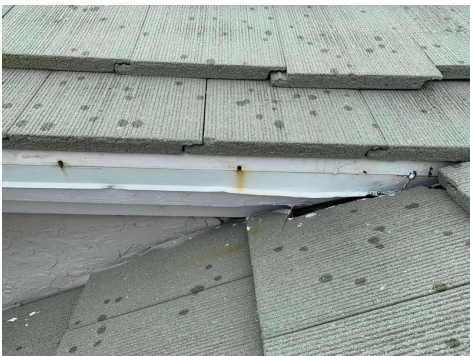
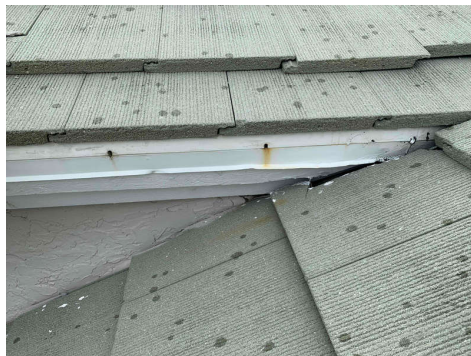
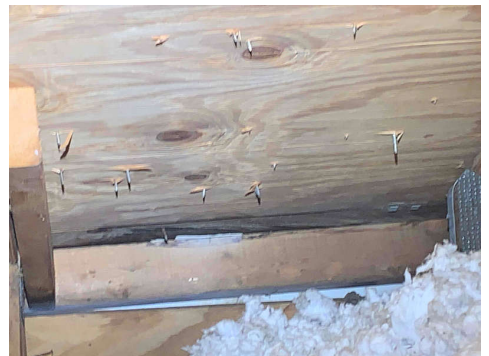
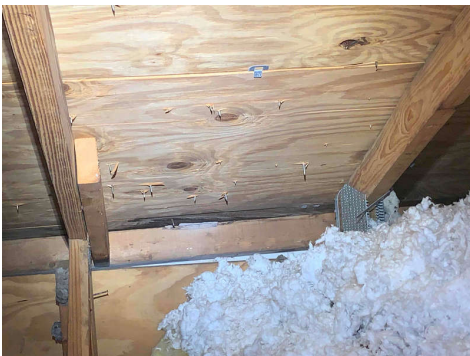
### 2.1.2 Coverings

#### **POTENTIAL LEAK FOUND IN ATTIC**

NORTH SIDE OF HOME NEAR FRONT ENTRANCE

During the inspection, a potential roof leak was found in the attic. Inspector was unable to confirm if roof leak was active or not due to the location of the damage. Inspector recommends hiring a licensed contractor to evaluate the damage and repair accordingly.

Contact a qualified professional.

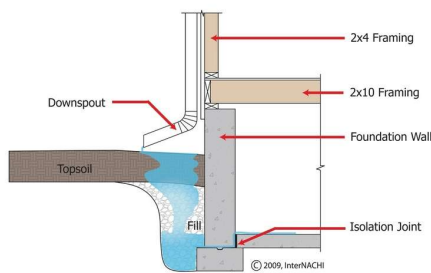
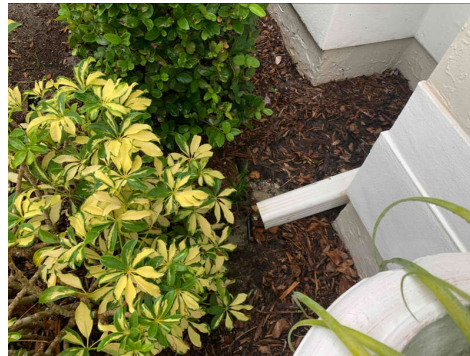
### 2.2.1 Roof Drainage Systems

#### **DOWNSPOUTS DRAIN NEAR HOUSE**

One or more downspouts drain too close to the home's foundation. This can result in excessive moisture in the soil at the foundation, which can lead to foundation/structural movement. Recommend a qualified contractor adjust downspout extensions to drain at least 6 feet from the foundation.

Moisture Intrusion - Downspout

Contact a qualified roofing professional.

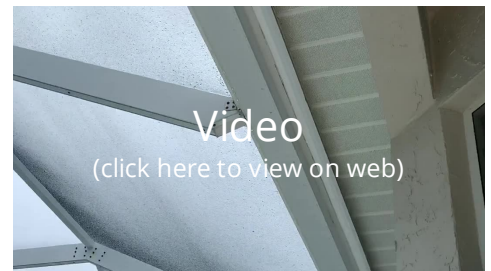
### 2.2.2 Roof Drainage Systems

#### **GUTTER LEAKAGE**

Gutters were observed to be leaking in one or more areas. This can result in excessive moisture in the soil at the foundation, or moisture around the fascia. Recommend a qualified contractor evaluate and repair gutters to proper functionality.

Contact a qualified roofing professional.

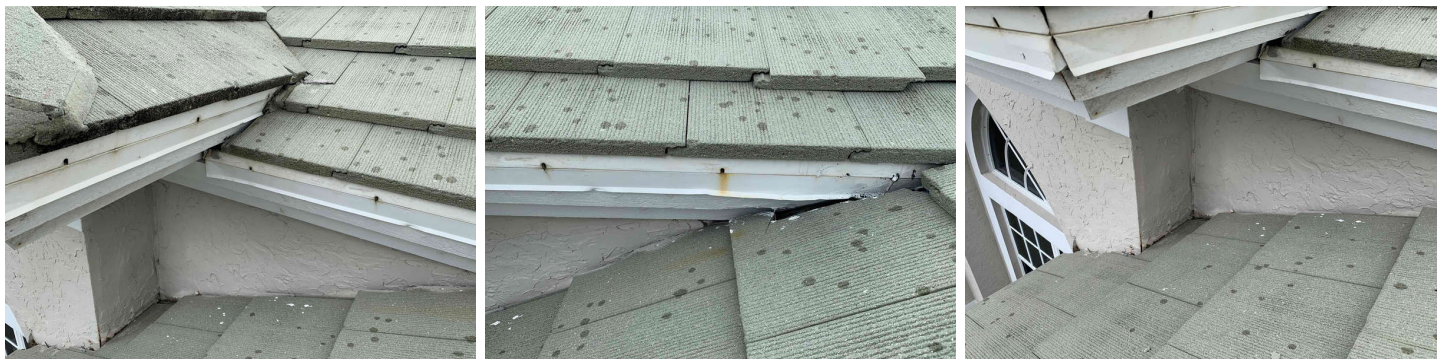
### 2.3.1 Flashings

#### **DAMAGE - MINOR**

Roof flashing showed signs of damage but are still in working condition. Flashing should be monitored to prevent severe corrosion leading to moisture intrusion.

Contact a qualified roofing professional.

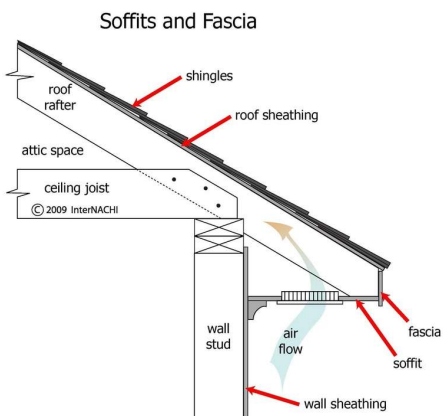
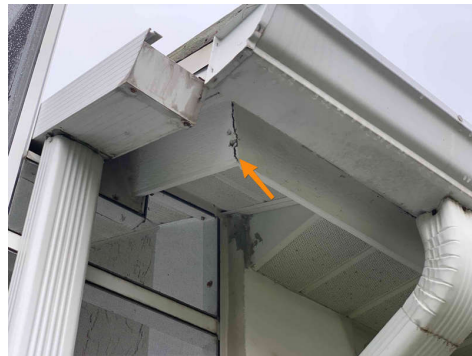
### 3.5.1 Eaves, Soffits & Fascia

#### **FASCIA - ROTTED**

One or more sections of the fascia are rotted. Recommend qualified roofer evaluate & repair.

Contact a qualified roofing professional.

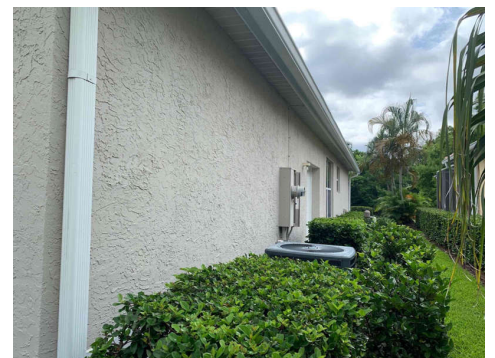
### 3.6.1 Vegetation, Grading, Drainage & Retaining Walls

#### **VEGETATION NEAR SIDING**

Vegetation should be at least 2 feet from siding. Vegetation too close to siding can cause water intrusion.

Contact a qualified landscaping contractor

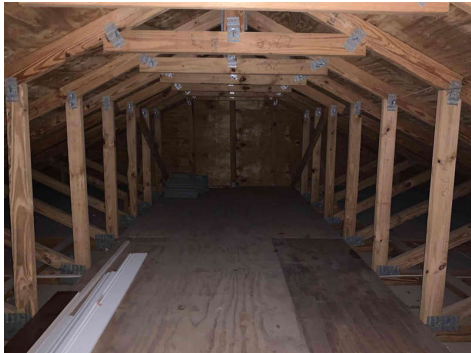
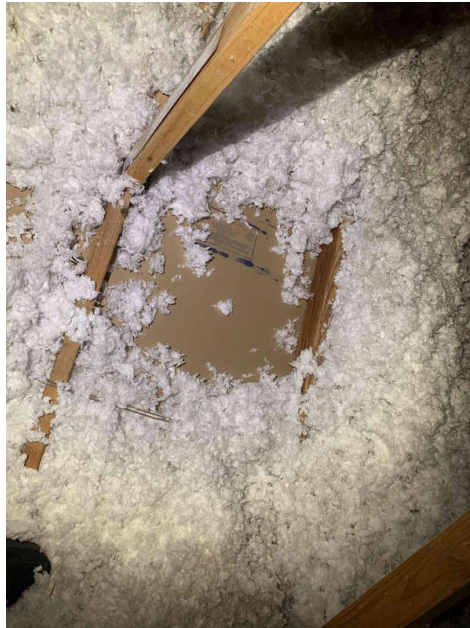
### 4.4.1 Insulation

#### **MISSING**

Ceiling insulation is missing in some areas. Recommend installing insulation where missing for better energy efficiency.

Contact a qualified insulation contractor.

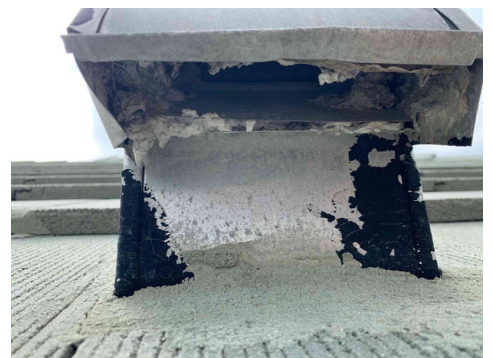
### 4.5.1 Ventilation

#### **EXCESSIVE LINT**

The dryer duct vent line passes through the attic and is vented to the exterior. It is recommended to have the vent line cleaned to prevent the lint from blowing into the attic. This is also a potential microbial causing issue due to the moisture from the dryer blowing into the attic.

Contact a qualified HVAC professional.

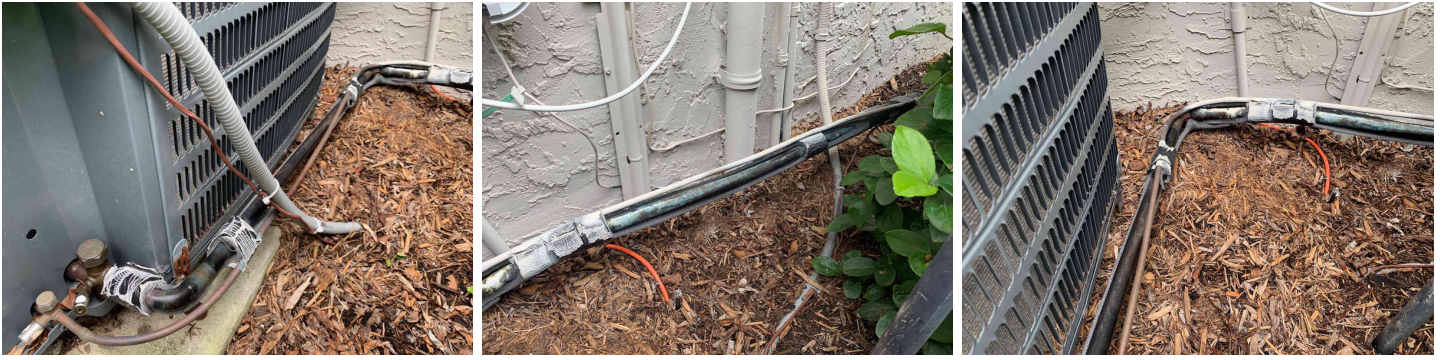
### 5.1.1 Cooling Equipment

#### **INSULATION MISSING OR DAMAGED**

Missing or damaged insulation on refrigerant line can cause energy loss and condensation.

Contact a qualified HVAC professional.

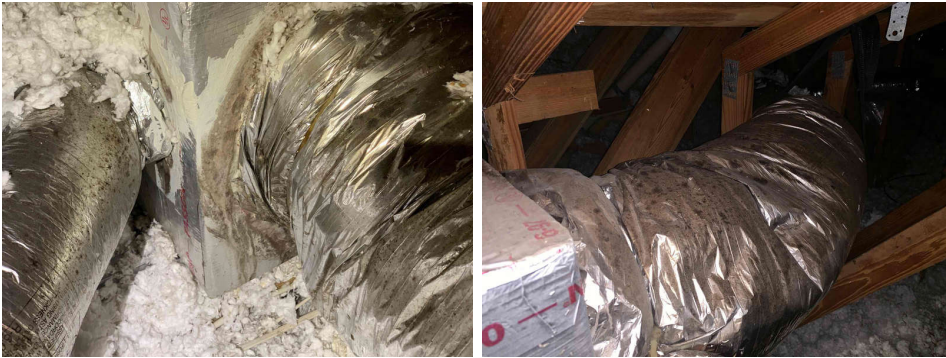
### 5.1.2 Cooling Equipment

#### **MICROBIAL GROWTH FOUND ON HVAC DUCT IN ATTIC**

Microbial growth found on HVAC registers located in the attic. Inspector recommends getting this tested and determining the type of growth. Being that there is a fresh air intake in the attic this could be a potential issue to the air quality of the home.

Contact a qualified professional.

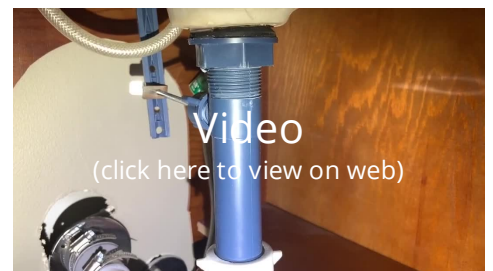
### 6.3.1 Water Supply, Distribution Systems & Fixtures

#### LEAK UNDER SINK

Leak detected under bathroom sink. Inspector recommends hiring a qualified plumbing professional to repair. Monitor for possible mold growth.

Contact a qualified plumbing contractor.

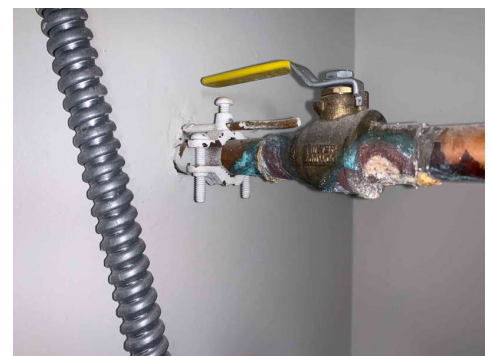
### 6.4.1 Hot Water Systems, Controls, Flues & Vents

#### CORROSION

Corrosion was noted at the burn chamber or pipe fittings. Recommend a qualified plumber evaluate for repair/replacement.

Contact a qualified plumbing contractor.

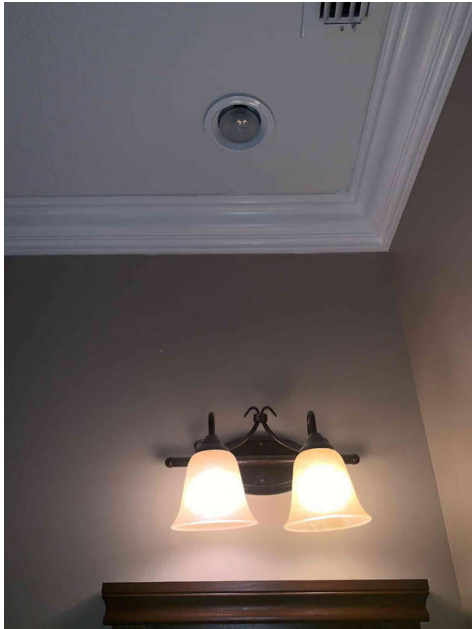
### 7.4.1 Lighting Fixtures, Switches & Receptacles

#### **LIGHT BULBS NEED REPLACING**

Contact a qualified professional.

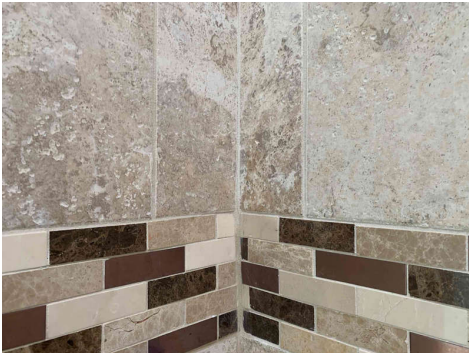
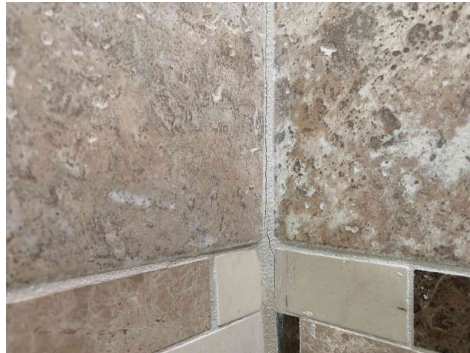
#### 8.4.1 Walls

### **SHOWER NEEDS GROUT**

Certain areas of the showers need more grout. Certain areas of tile are deteriorating. Inspector recommends fixing immediately to avoid water damage.

Contact a qualified professional.

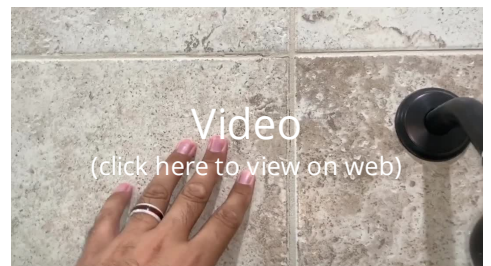
#### 8.4.2 Walls

### **LOOSE TILES IN SHOWER**

Certain tiles in master bathroom shower sounded hollow and were loose at time of inspection. Inspector recommends removal of tiles to inspect wall behind the tile and determine if repair or replacement is in order.

Contact a qualified professional.

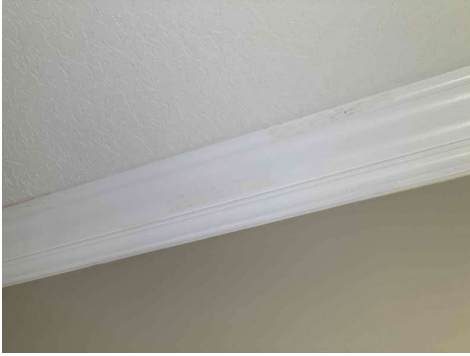
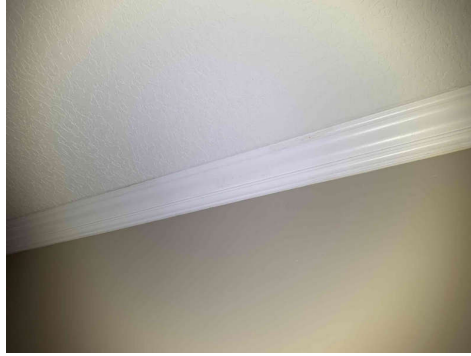
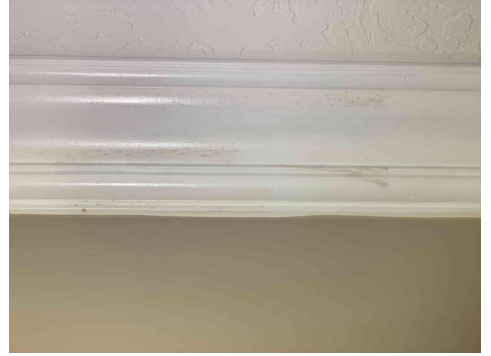
## 8.5.1 Ceilings

**STAIN(S) ON CEILING**

There is a stain on ceiling/wall that requires repair and paint. Source of staining should be determined.

Contact a qualified professional.

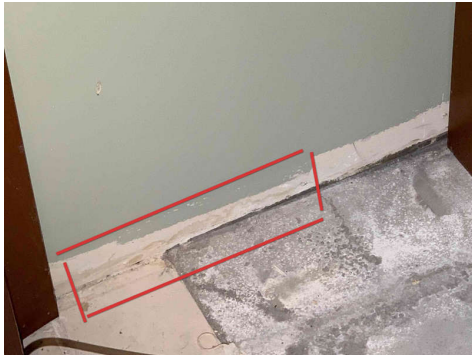
**PREVIOUS LEAK BEHIND REFRIGERATOR.**

Contact a qualified professional.

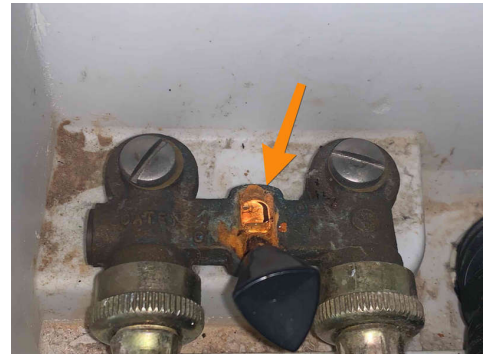
#### **WATER VALVE LEAKING**

One of the water valves is leaking. The valve should be repaired or replaced.

Contact a qualified plumbing contractor.

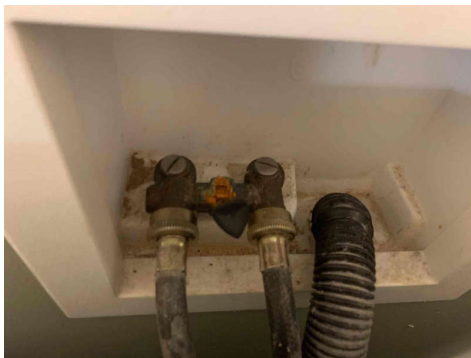
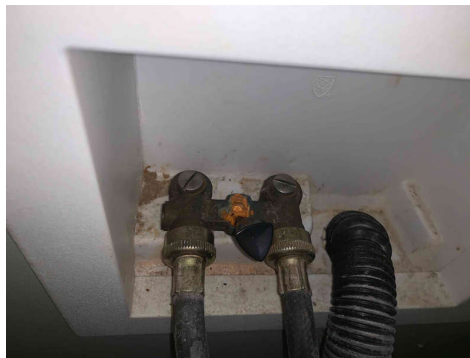
### 10.1.2 General

#### **CORROSION ON FITTINGS/LINES**

Corrosion was found on fittings and/or water supply lines for the clothes washing machine. Leaks may occur. A qualified plumbing contractor should evaluate and repair as necessary.

Contact a qualified professional.
